**FINAL REPORT OF COMPREHENSIVE EVALUATION FOR  
ASBESTOS-CONTAINING MATERIALS SURVEY, PCB BALLAST, MERCURY  
VAPOR BULB, AND HEAVY METAL CONTAMINATED COATING,**

P-625, BUILDING 701 and 606, SUBSTATION 531, TRANSFORMER 662  
SIGONELLA - NAS II  
SICILY, ITALY

**MACTEC PROJECT NO. 40280-2-2008/\*\*/606**

February 25, 2003

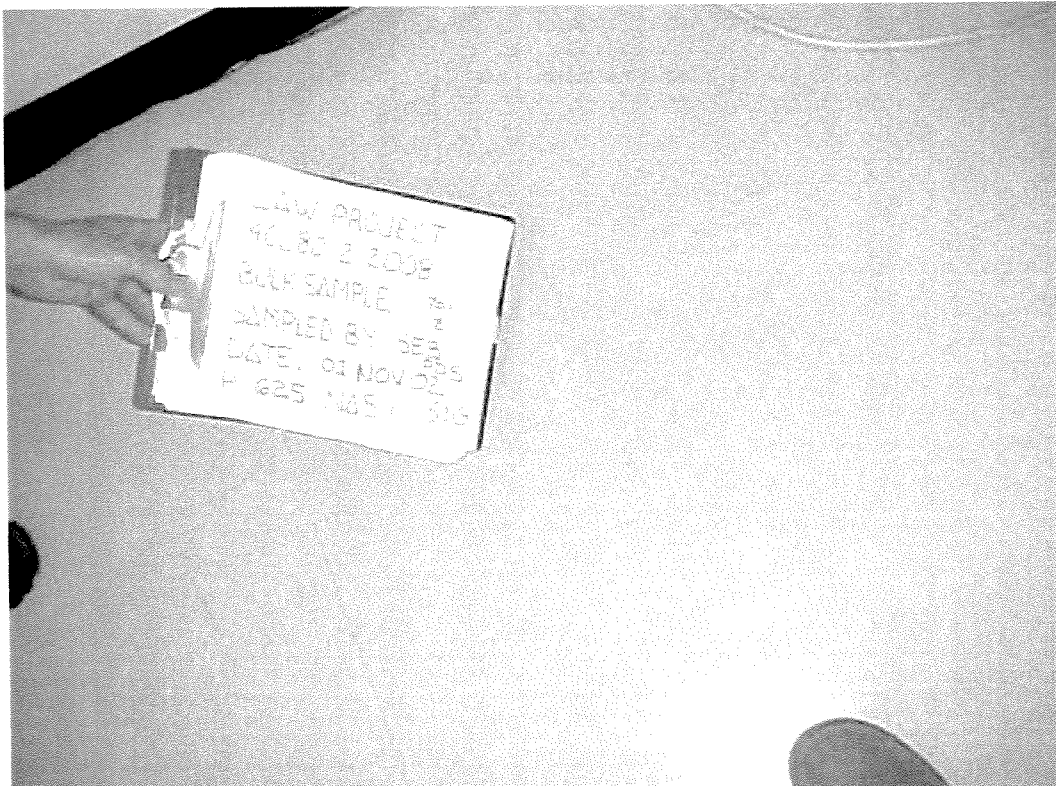
A total of 5 homogenous areas of suspect asbestos-containing materials were observed and sampled within the facility. Asbestos-containing Category I materials were identified within the facility include black mastic under vinyl floor tile. No Category II or friable asbestos-containing materials were identified within the facility.

Building 701 – Asbestos-containing 12"x12" gray floor tile with black mastic, Sample 2.

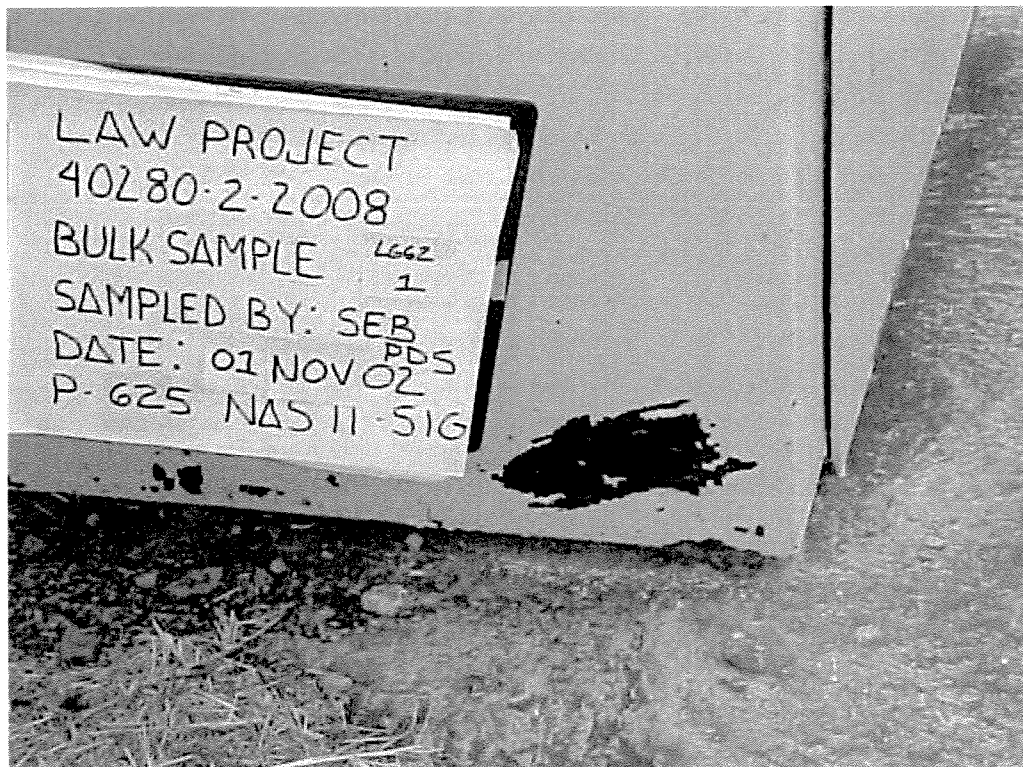
Transformer 662 – Lead-Based Paint Sample Number L-1, beige metal transformer housing.

SAMPLE NO.	FLOOR	COLOR	COMPONENT	LOCATION / HA	SUBSTRATE	ORIENTATION	CONDITION	Pb%
L662-1	0	Beige	Unit	Exterior	M	Top	F-M	<0.01
COMMENTS	Typical of all exterior surfaces							
COMMENTS								
COMMENTS								
COMMENTS								
COMMENTS								
COMMENTS								
COMMENTS								
COMMENTS								
COMMENTS								
COMMENTS
